# Heldervue – Clearing their “vue” to ensure sustainable water resource management

Written by Marige Carstens (GEOSS South Africa (Pty) Ltd), 04 June 2024 (mcarstens@geoss.co.za)

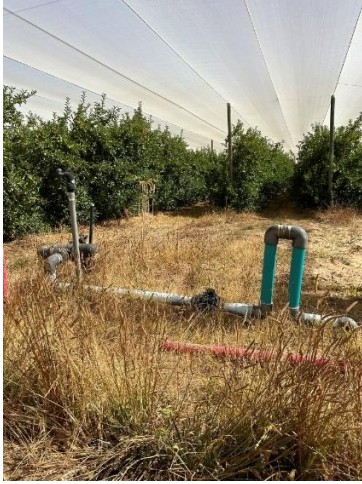
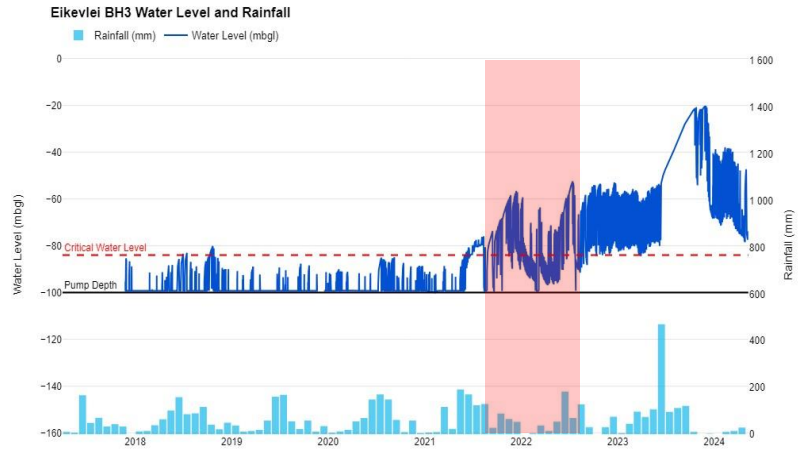
Figure 4 Eikevlei BH3 Water Level and Monthly Rainfall (2017 – 2024 YTD)

In **Figure 4**, the consequence of the drought can be observed from 2018 to 2021, when pumped water levels were running at the pump inlet. This poses a risk of burning out the pump and dewatering the aquifer and is a result of insufficient recharge and increased abstraction due to below-average rainfall. Eikevlei BH3 is one of the main production boreholes on the farm and could not be left to rest. The period when alien clearing occurred is marked with a red band on the graph in **Figure 4**. It is evident that since alien clearing started in August 2021, water levels have begun to rise. The recharge potential on the farm increased and the good rainfall of 2023 resulted in reduced abstraction. Before alien clearing, the static water level was 80 meters below ground level (mbgl). After the good rainfall of 2023, and the completion of the alien clearing in August 2022, static water levels were 20 mbgl. **The static groundwater level recovered by an astonishing 60 meters.** The water level has since dropped during the 2023-2024 summer period, as abstraction increased and rainfall reduced but still demonstrates significant improvement.

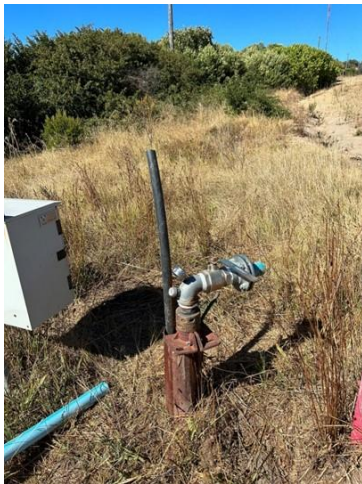
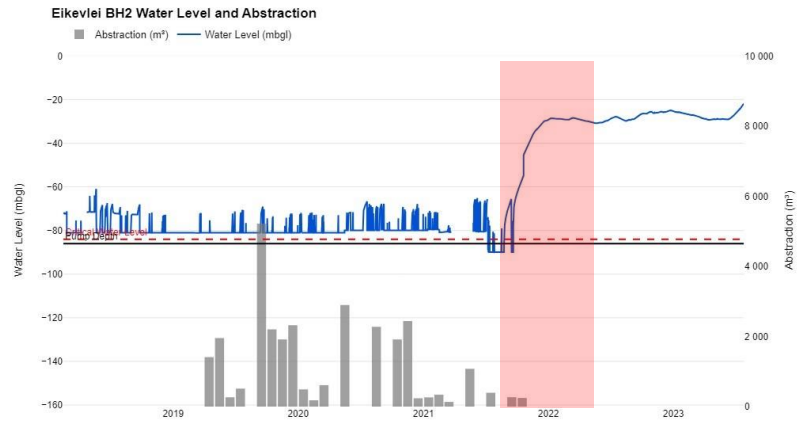
Figure 5 Eikevlei BH2 Water Level and Monthly Abstraction (2018 – 2023)

In **Figure 5**, a decommissioned borehole, Eikevlei BH2, is shown. This borehole can be considered a proper monitoring borehole, as no abstraction has been taking place since the end of 2021, when water levels dropped below the pump inlet. The period when alien clearing took place (August 2021 – August 2022) is also marked with a red band on the graph in **Figure 5**. Since abstraction ceased, and the alien vegetation cleared, water levels continued to rise. Static water levels were 70 mbgl before 2022. Manual water level measurements obtained in January 2024 showed that the static water level was ~10 mbgl, **also indicating a 60 m rise in the groundwater levels**. During May 2024, the water level was still at ~20 mbgl, according to manual measurements.
